FIG. 6 is a block diagram of a system 600 for providing a beauty care facility access system.

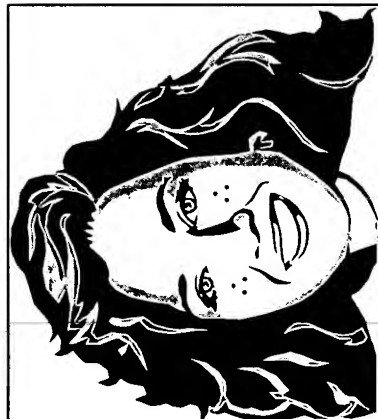
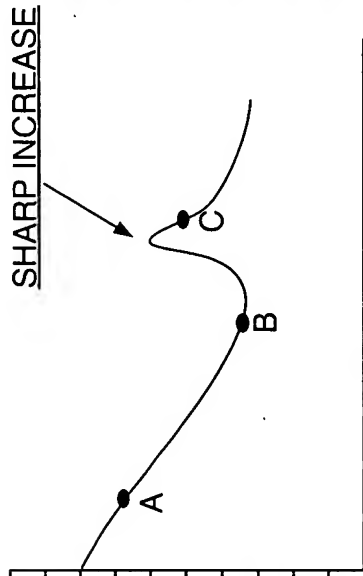
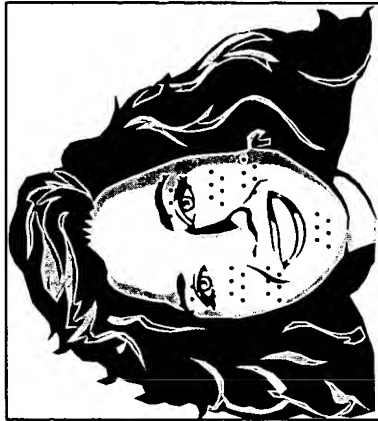
FIGURE 5

YOU WERE EXPOSED TO INTENSE SUNLIGHT LAST YEAR DURING YOUR VACATION FROM 7/1/01 TO 7/14/01. BECAUSE OF THIS EXPOSURE, YOUR FRECKLE INTENSITY INCREASED SHARPLY, AS SHOWN IN THE CHART. THEREFORE, IF YOU PLAN ANOTHER VACATION THIS SUMMER, IT IS RECOMMENDED THAT YOU BEGIN PREVENTIVE TREATMENT THREE WEEKS IN ADVANCE. BELOW IS A LIST OF RECOMMENDED PRODUCTS.

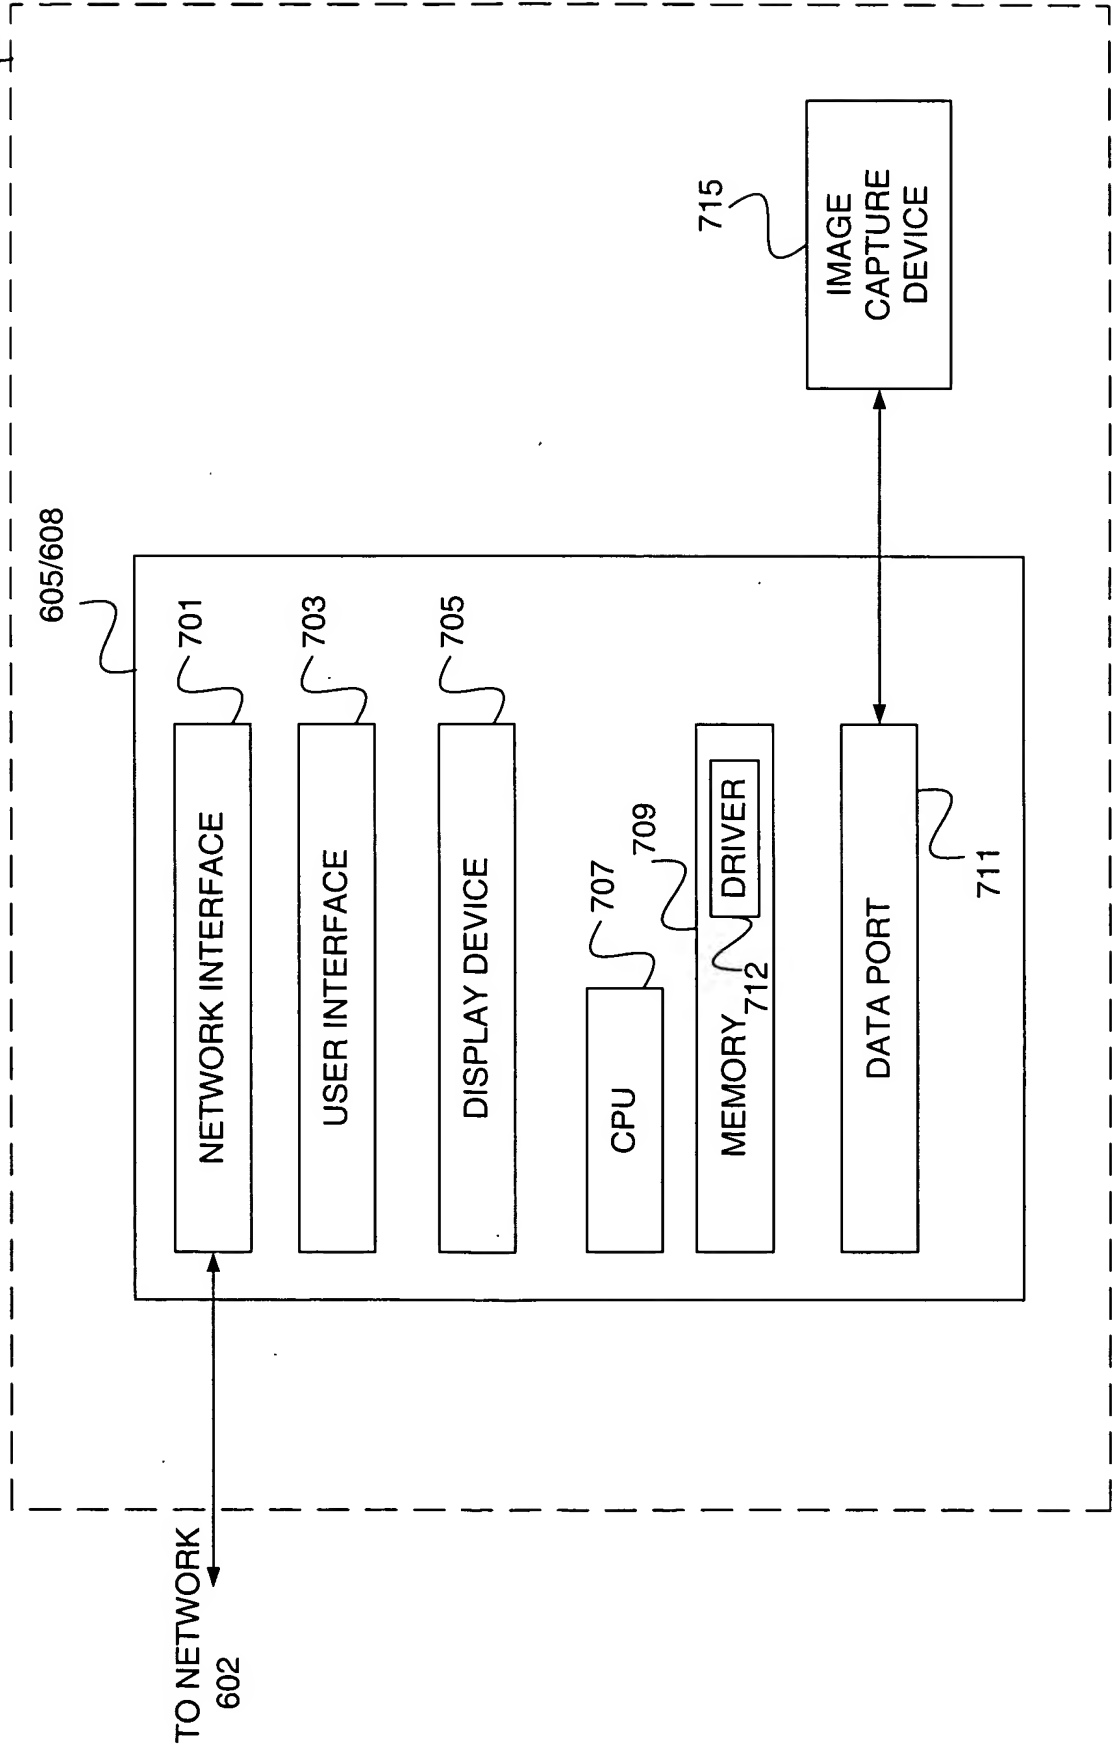
FIGURE 7

FIG. 7 is a block diagram of a system 600 in accordance with one embodiment of the present invention. The system 600 includes a network interface 701, a user interface 703, a display device 705, a CPU 707, a memory 712, a driver 709, a data port 711, and an image capture device 715. The network interface 701 is connected to a network 602. The user interface 703, display device 705, CPU 707, memory 712, driver 709, and data port 711 are all connected to a central processing unit 604/607. The image capture device 715 is connected to the data port 711.
